MATERIALS TEST REPORT

Ref. 411104

Date November 14, 2023

Sample: QTY (1) – Inconel 718 Tiedown

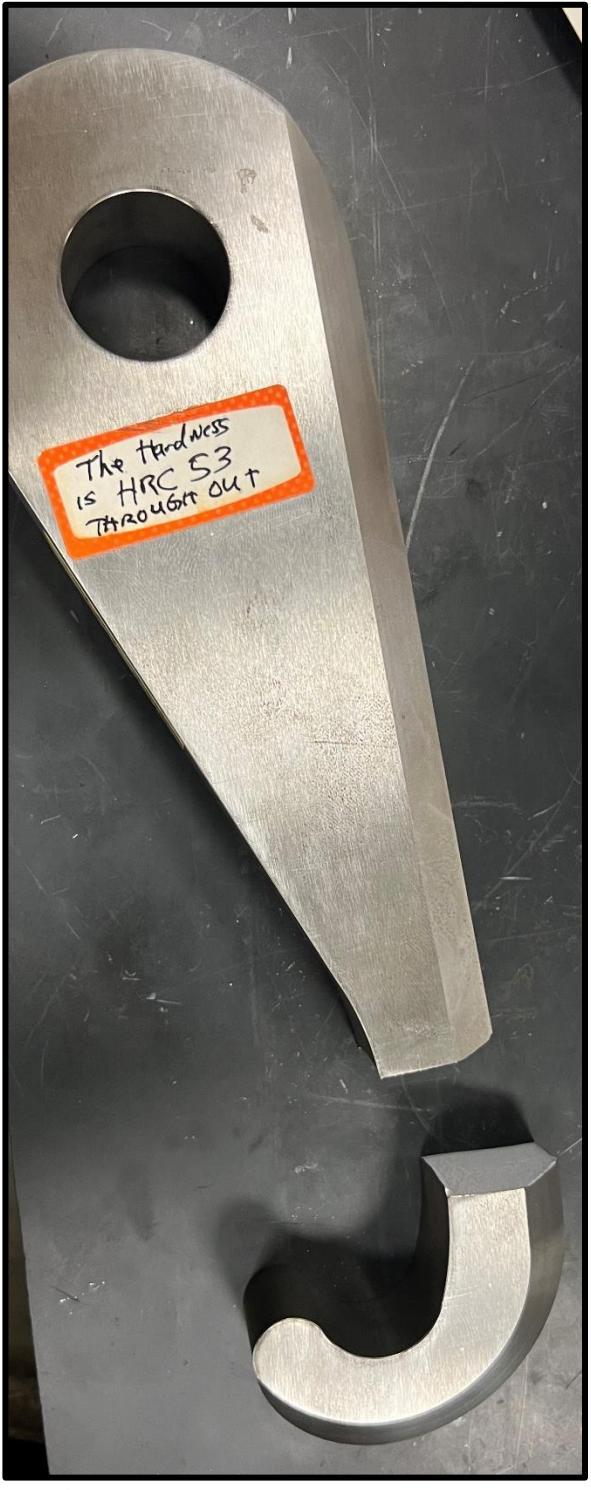
Configuration	Load (lbf)	One Minute Hold	Three Minute Hold	Remarks
Asymmetrical	25,000	PASS	PASS*	*The asymmetrical secondary loading was set to a 5-minute hold and a fixture hook failed at 4.5 minutes. Test article showed no sign of damage.
Symmetrical	32,000	PASS	PASS

Figure 4: Asymmetrical loading fixture hook failure

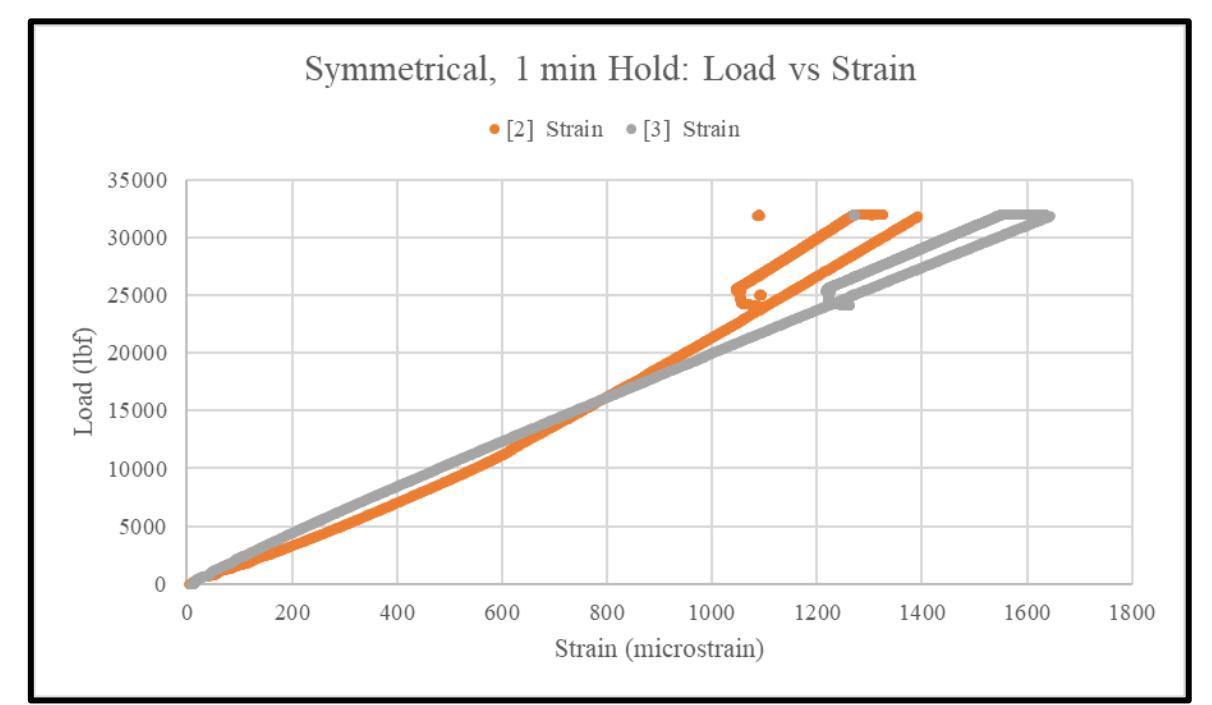
Figure 7: Strain vs. Load for the symmetrical configuration. The program ramped down to the asymmetrical load and it was corrected during the test.
